Manhole Inspection Summary

Manhole # S47M__009MH

Record Plat: **47M** Node: **009** Status: **New Manhole (Not in GIS)** Insp Date: **9/5/08 12:00 AM**

Location Address: **2341-1 boston st**

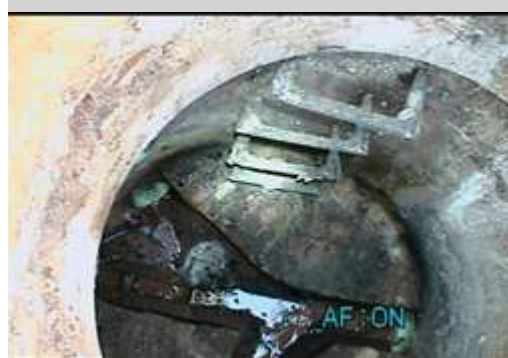
Defect 2

channel debris

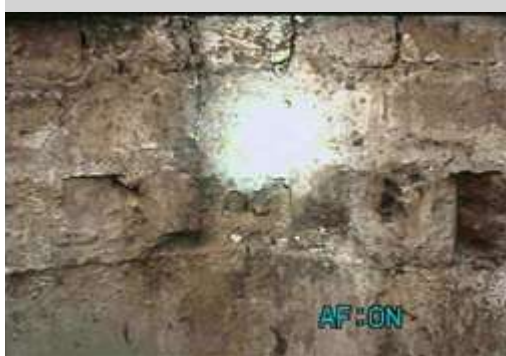
Defect 1

Condition: ☐ Sound ☒ **Cracked** ☐ Root Intrusion ☒ **Loose Brick** ☒ **Deteriorated**

steps

chimney loose bricks,
cracked,deteriorated,
frame adj

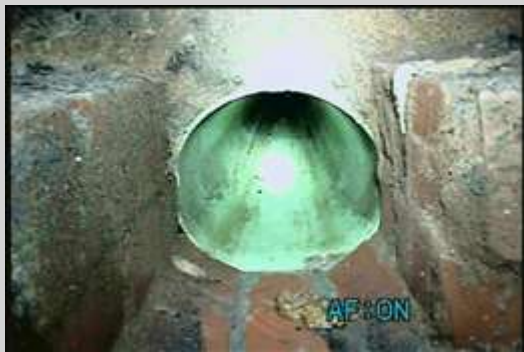
12 O'Clock Outflow

8 in. Circular Gravity Sewer
Pipe Out @ 12 O'Clock

Pipe Height: **0** (in.) Direct
Pipe Material: **PVC** ☐ Pipe Lined
Invert Depth: **7.00** (ft.) Flow Characteristics: **Fast**
Deposits: ☒ None ☐ Mud ☐ Sludge ☐ Debris ☐ Grease
Silt Depth: **0** (in.) Deposits Extent:
Infiltration: **None** Pipe Seal Cond: **Unknown**

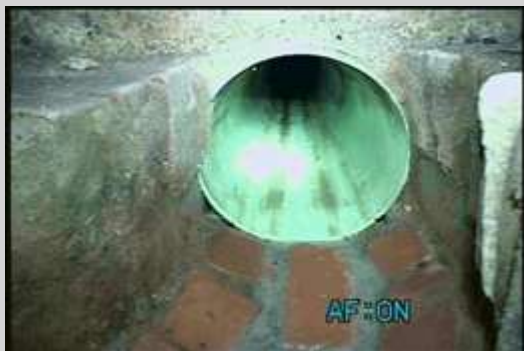
3 O'Clock Inflow

8 in. Circular Gravity Sewer
Pipe In @ 3 O'Clock

Pipe Height: **0** (in.) Direct
Pipe Material: **PVC** ☐ Pipe Lined
Invert Depth: **6.67** (ft.) Flow Characteristics: **Fast**
Deposits: ☒ None ☐ Mud ☐ Sludge ☐ Debris ☐ Grease
Silt Depth: **0** (in.) Deposits Extent:
Infiltration: **None** Pipe Seal Cond: **Unknown**

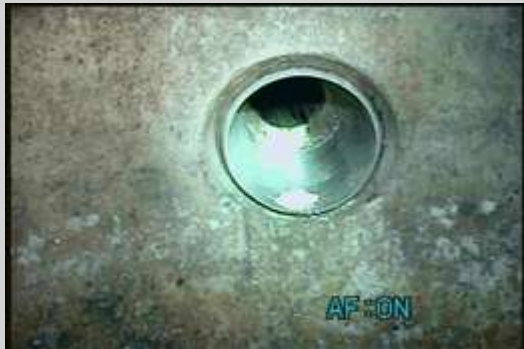
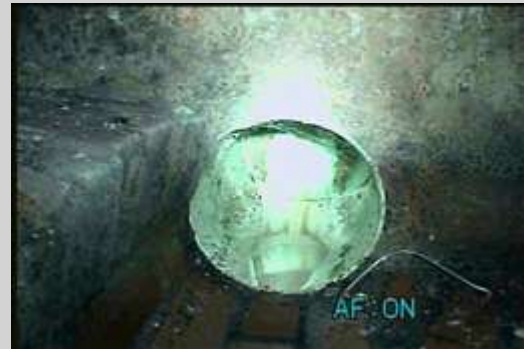
6 O'Clock Inflow

Drop: **Outside** **Direct**

Drop Condition: **Open**

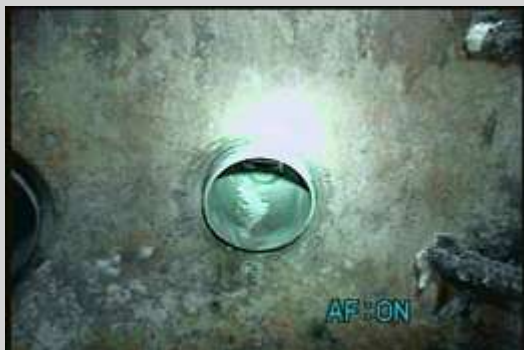
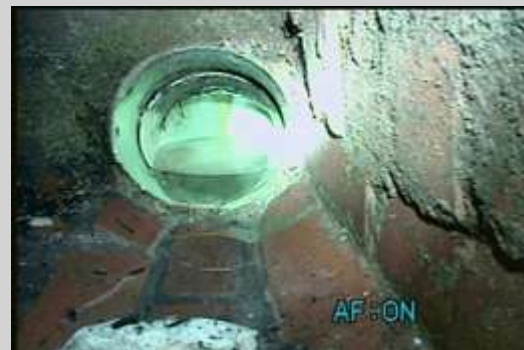
7 O'Clock Inflow

Drop: **Outside** **Direct**

Drop Condition: **Open**

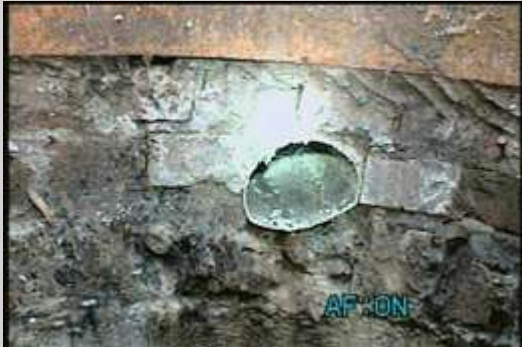
11 O'Clock Inflow

pipe is 1.46 feet down not 2
